Re: Notice of Violation
Compliance Evaluation Inspection
WID 000 000 356

SITE NAME: WM MERCURY WASTE, INC.
EPA ID NUMBER: WIR 000 000 356
ADDRESS: 21211 Durand Avenue, Union Grove, Wisconsin 53182-9711
DATE OF INSPECTION: February 14, 2013
EPA INSPECTOR: Cindy Dabner
Environmental Scientist

Attachment A
Photographs for WM Mercury Waste, Inc. RCRA CEI
WID 006 097 281
February 14, 2013

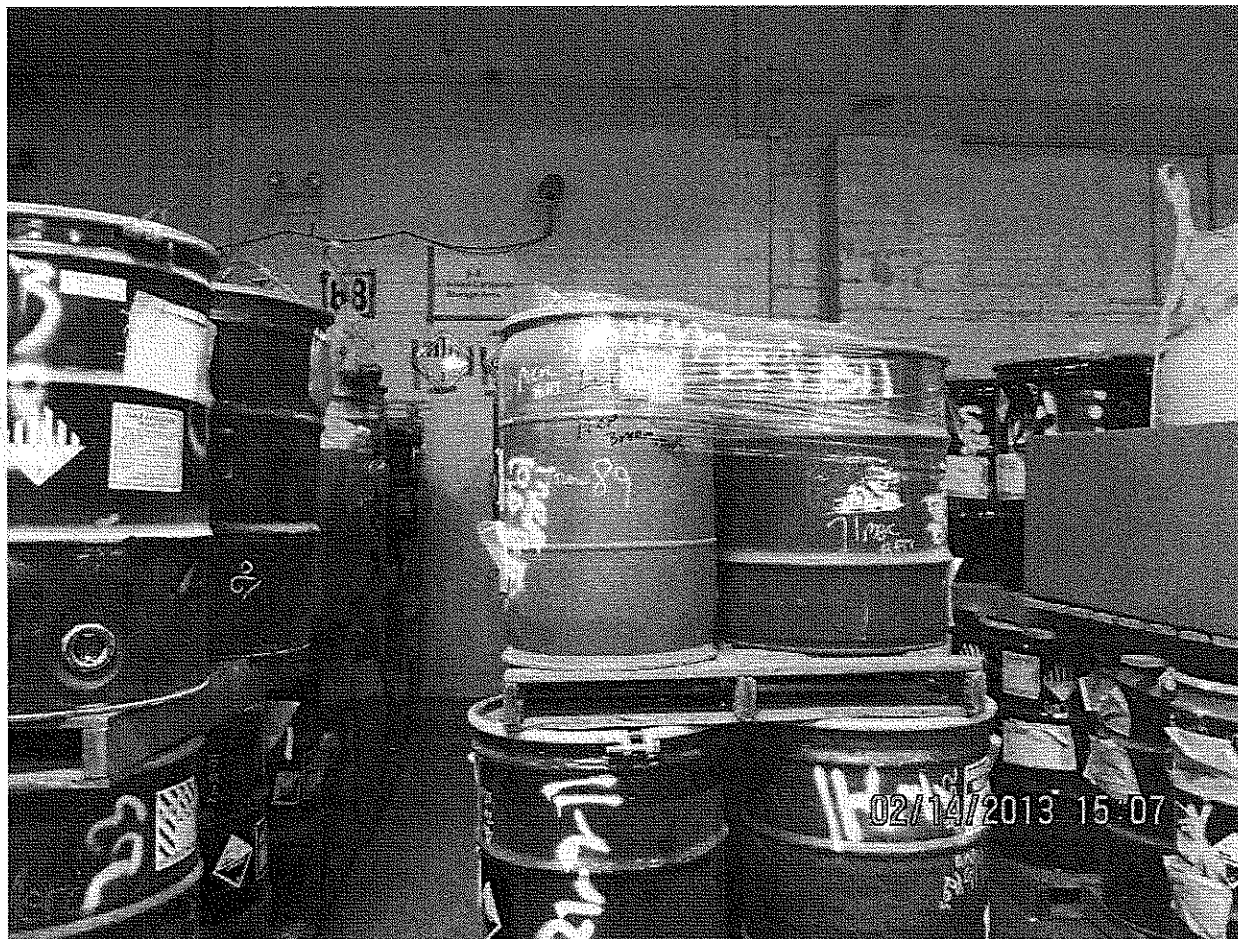
Photograph: #35

Next the inspection continued to S-5 of the East Building. At this location, at least 50 drums and containers of hazardous waste and universal waste were observed at this licensed storage area location. The inspector observed each of the drums. Each of the drums were properly marked as universal waste with accumulation dates or hazardous waste with hazardous waste codes and accumulation start dates along with DOT shipping information. See Photograph #34 -35.

Description: Hazardous Waste Located in S-5 of the East Building

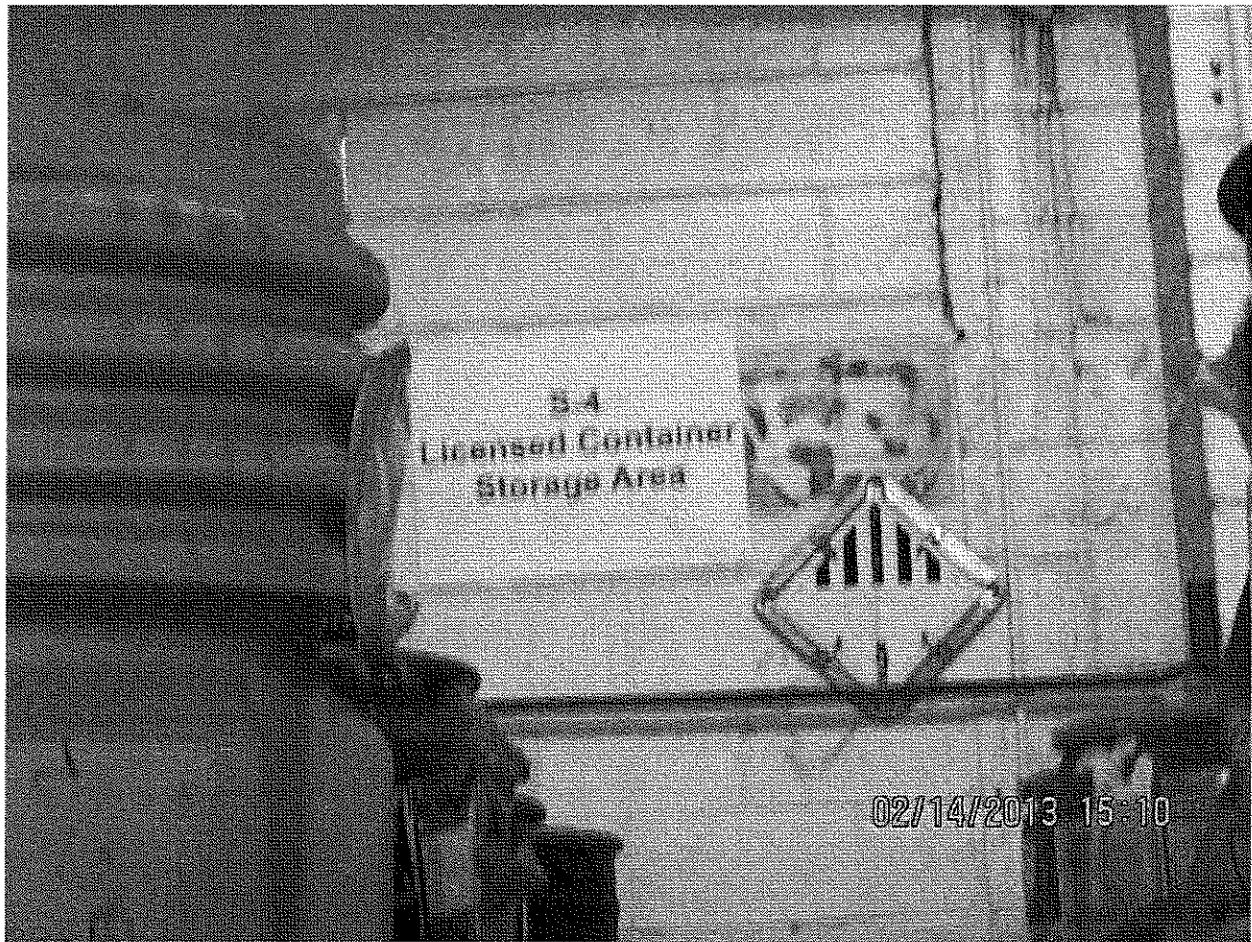
Finally at S-4 of the East Building, the inspector observed at least 50 drums and containers of hazardous waste and universal waste were observed at this licensed storage area location. The inspector observed each of the drums and containers. Each of the drums and containers were properly marked as universal waste with accumulation dates or hazardous waste with hazardous waste codes and accumulation start dates along with DOT shipping information. See Photograph #36-37.

Photograph: #36
Name of Photographer: Cindy Dabner
Date/Time of Photograph: February 13, 2013
Site Location: 21211 Durand Avenue, Union Grove, WI 53182
Description: S-4 Licensed Container Storage Area

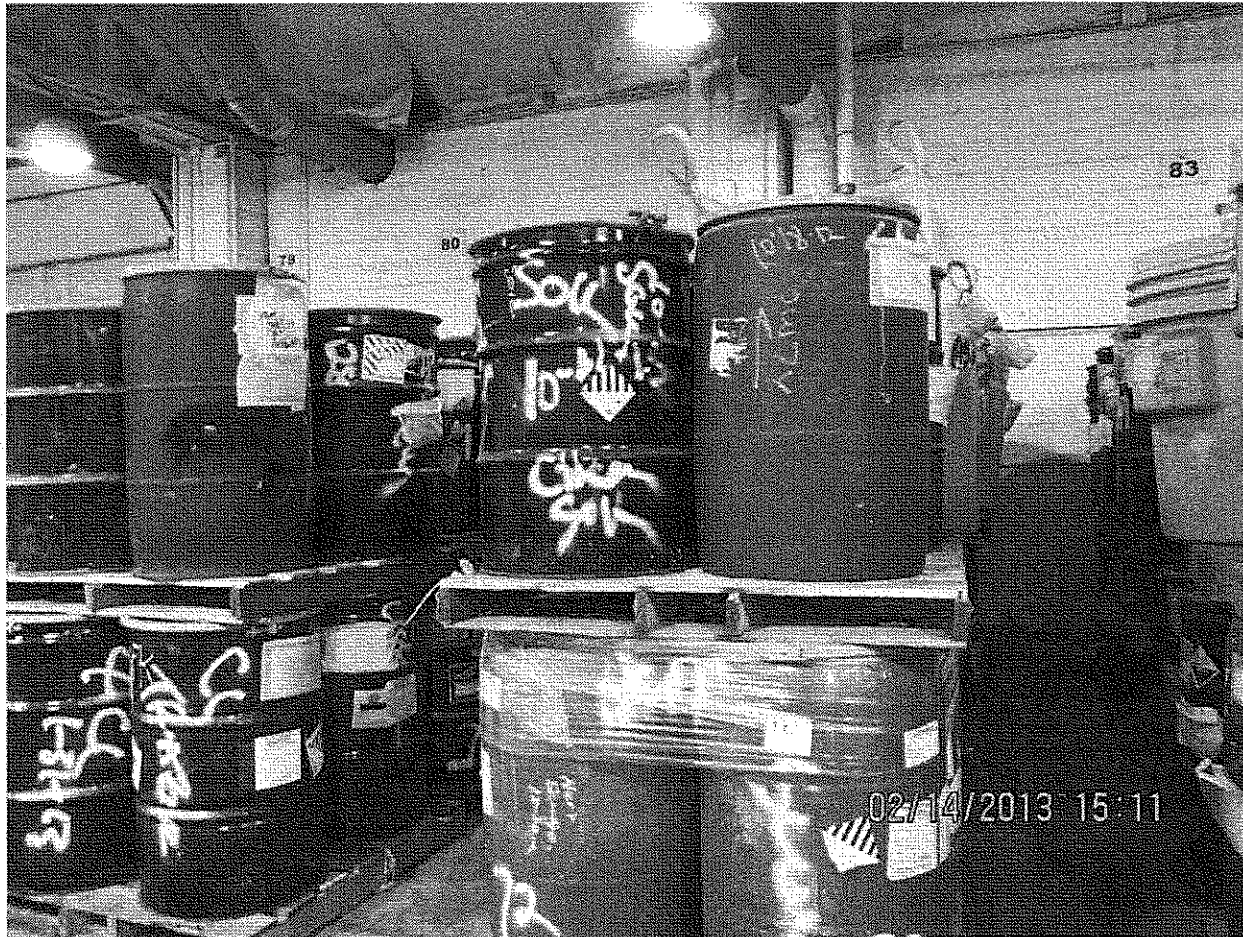
Photograph: #37

Description: Hazardous Waste Drums Located in S-4 of the East Building
